## Mold Inspection Report

Property Address:  
5 Sheldon Road  
Dampton, NY 12345

<b>Date:</b> 8/7/2007	<b>Time:</b> 10:00 AM	<b>Report ID:</b> Mold Sample 1
Property: 5 Sheldon Road Dampdown, NY 12345	Customer: Teri Smith	Real Estate Professional:

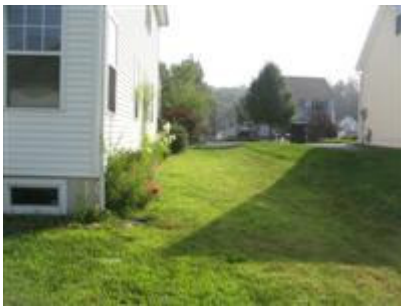
2.0 Picture 1

2.0 Neutral drainage seen at right side (facing front). (Picture 1) This area may not drain surface water away from property. Monitor for pooling after heavy rains. Corrective action may be needed if you see water infiltration occurring over time.

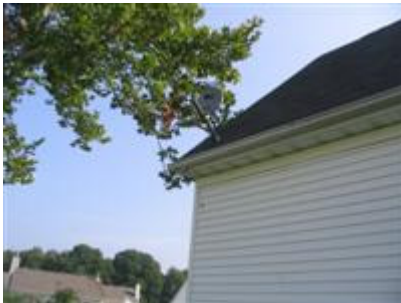
5.3 Picture 1

5.3 Gutters on a home with close tree cover may require frequent cleaning to keep them operating properly.(Picture 1) If gutters overflow, they can cause moisture to infiltrate the foundation.

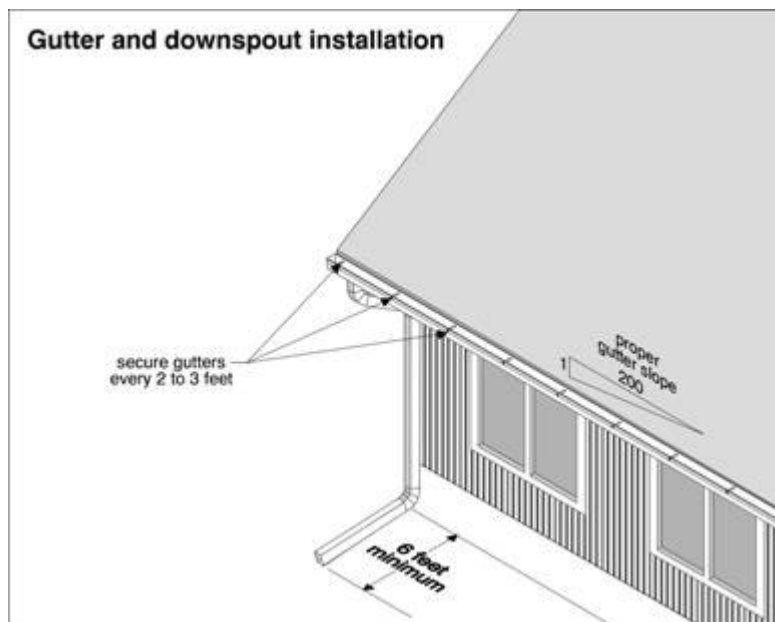
5.4 Picture 1

5.4 At least one downspout discharges close to the building. This can put excessive dampness/soil pressure against the foundation. Recommend ensuring that downspouts can drain their water away from the foundation.

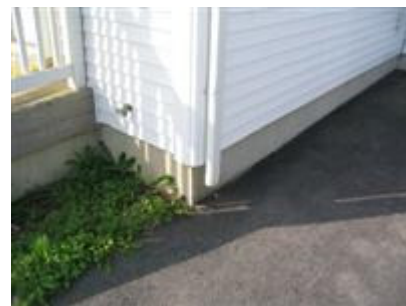
5.4 Picture 2

Downspout by the driveway lacked needed and elbow. (Picture 2)

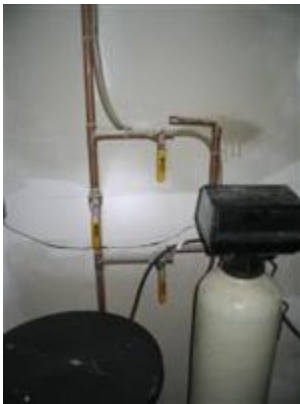
6.1 Picture 1

6.1 The piping at the water softener was disconnected and the control valves were leaking. (Picture 1)

As originally reported, poor winterization practices resulted in numerous burst plumbing pipes in the residence. Some of the burst distribution piping has been recently repaired. There are other sections which appear to still be leaking as evidenced by moisture in the walls and ceiling below their chases.

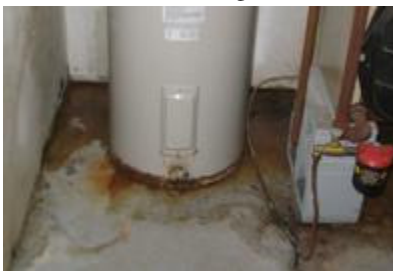
6.2 Picture 1

6.2 Water heater had significant rust at its base and it was surrounded by standing water. It appeared to be leaking.

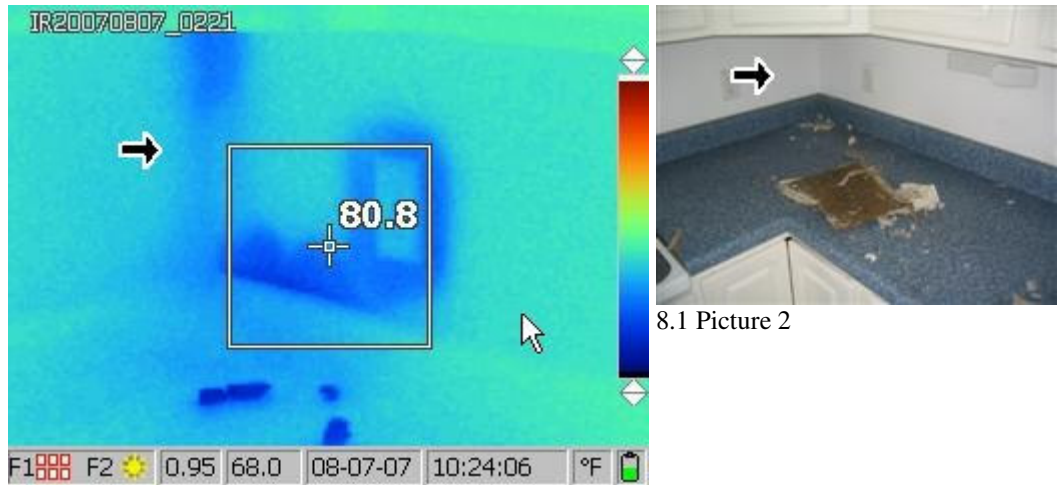
8.1 Infrared imagery of wall at corner by cabinets showed moisture. (Picture 1) (Picture 2)

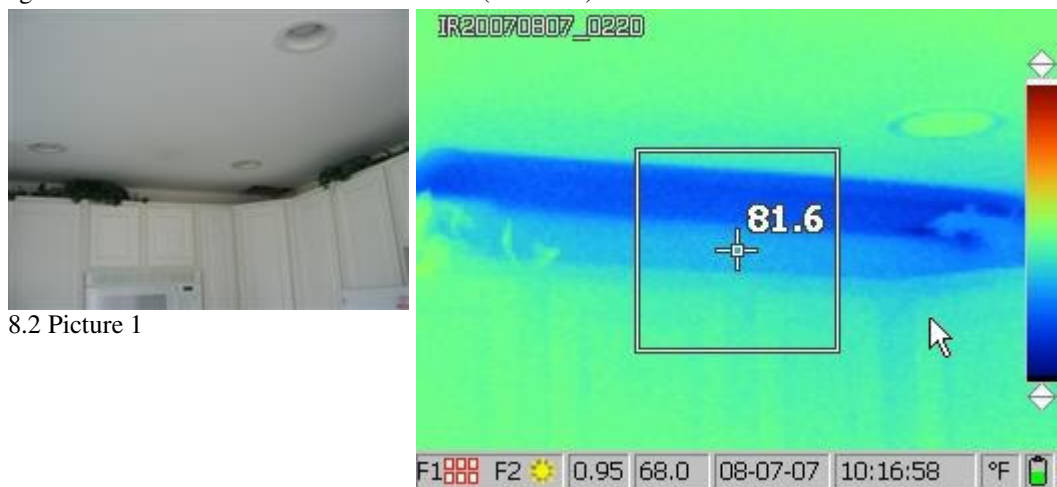
8.2 Ceiling in kitchen had sheetrock damage due to plumbing leaks and ongoing repairs. (Picture 1) Infrared imagery showed significant water saturation in the sheetrock. (Picture 2) I recommend the sheetrock in this area be replaced.

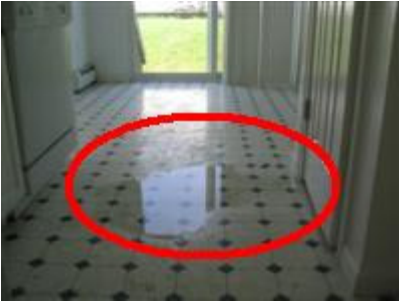
8.3 Picture 1

8.3 Standing water seen in the kitchen. (Picture 1)

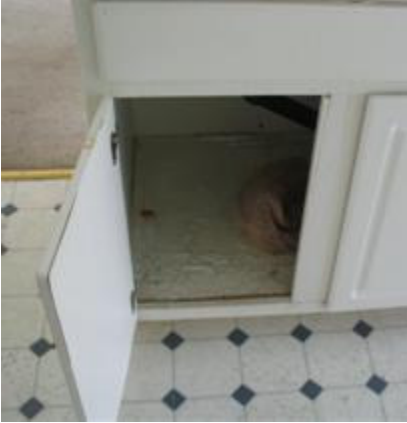
8.5 Picture 1

8.5 The cabinet shows signs of recent moisture problems/water event and probable microbial activity.(Picture 1)  
Suggest repair or replace affected cabinet.

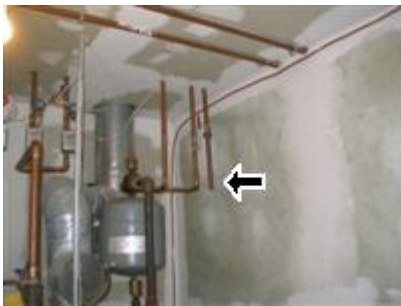
9.0 Picture 1

9.0 No heat registers in the basement are connected to the boiler. The pipe was disconnected. (Picture 1)

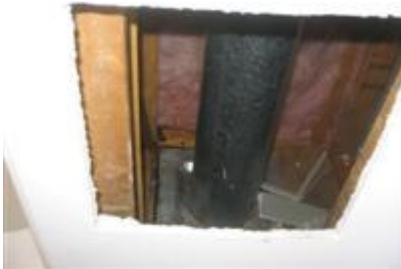
10.1 Picture 1

10.1 There was a hole cut into the wall of the shared bath for ongoing repairs. (Picture 1) There were signs of moisture from plumbing leaks in this area.

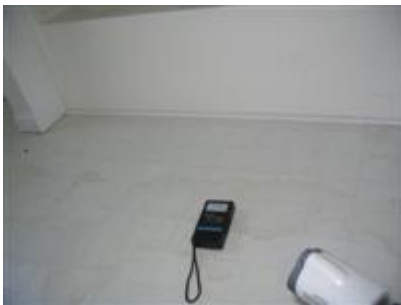
10.3 Picture 1

10.3 Moisture was detected below the vinyl flooring in both bathrooms. Dampness is trapped below the floor covering.

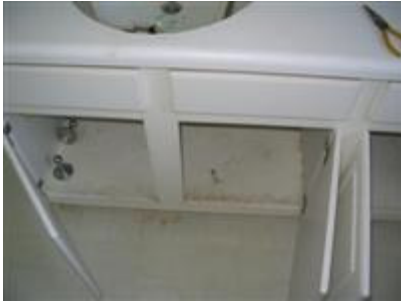
10.5 Picture 1

10.5 The vanities shows signs of recent moisture problems/water event and probable microbial activity.(Picture 1) Suggest repair or replace affected cabinet.

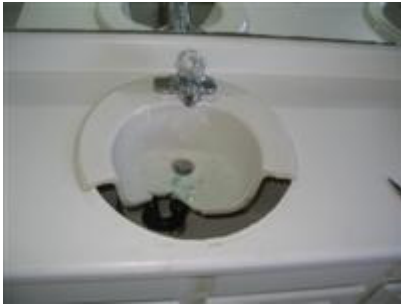
10.7 Picture 1

10.7 One sink in the master bath was broken. (Picture 1)

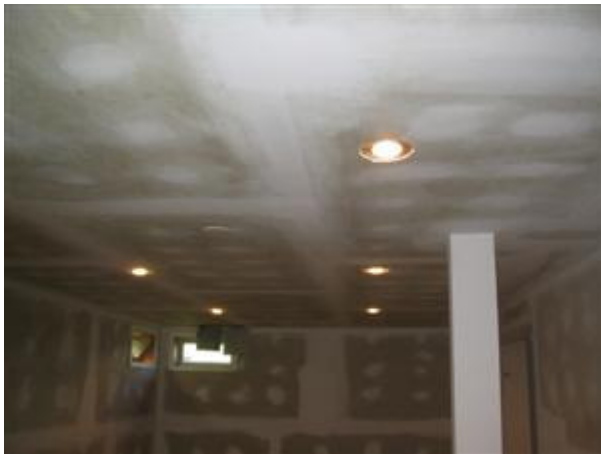
11.1.A Picture 1

11.0.A Mold was seen on virtually all surface areas of the basement. There was a strong musty odor.

Overall visible contamination was in excess of one hundred square feet (EPA large scale remediation).

11.1.A All ceilings in the basement showed visible contamination from mold.

I recommend containment and remediation be performed by a contracting company specializing in mold remediation. Some of the sheetrock may be salvageable, some will need to be removed and replaced. Sheetrock that has been soaked and has become soft is not salvageable.

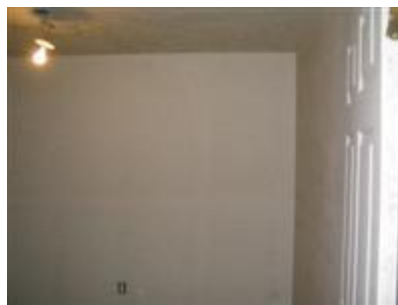
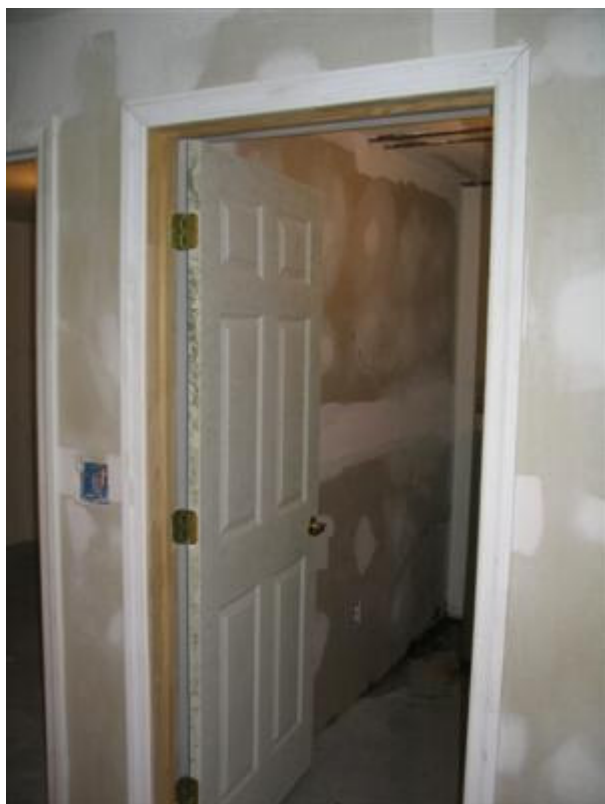
11.2.A All walls and doors in the basement showed visible contamination from mold.

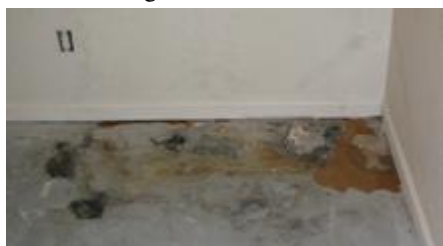
11.3.A Picture 1

11.3.A Standing water seen in the middle utility room.

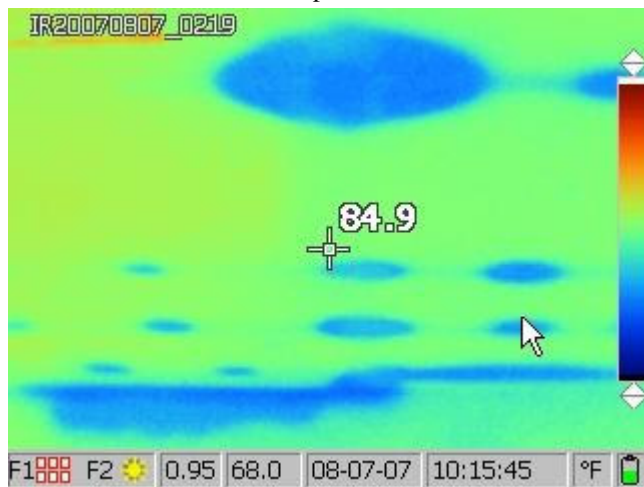
11.1.B Picture 1

11.1.B Infrared imagery detected significant signs of dampness in the ceiling. (Picture 1) There were also several water stains visible. The stains were damp when tested with a moisture meter.

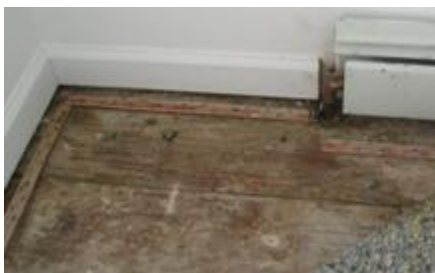
12.3 Picture 1

12.3 Bedroom floors were damaged from burst baseboard register pipes. (Picture 1) The carpeting was damaged and needs.

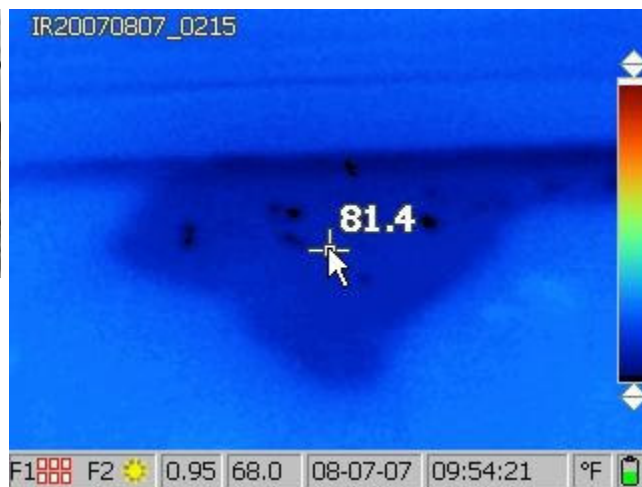
12.3 Picture 2

Infrared image showed active leaking in the bonus room. (Picture 2)
