Residential Energy Report

Property Address:
111 Maple Ave.
Sample City, NY 12345

American Home Inspections

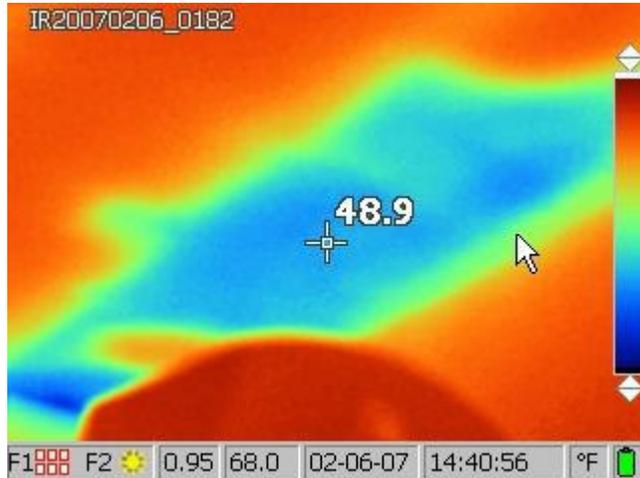
2.0 Picture 1

2.0 There were signs of insulation voids at the ceiling of the sunroom by near the utility door.(Picture 1) (Picture 2) The void was relatively small, but you may wish to better insulate it.

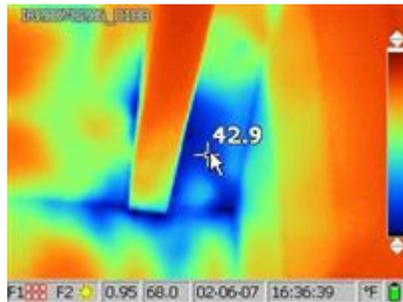
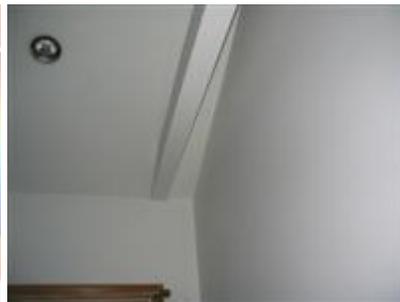
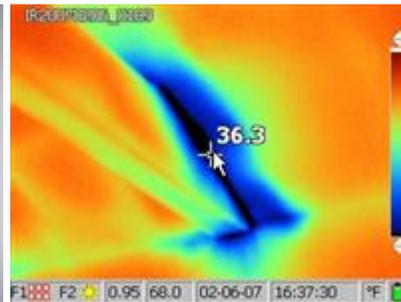
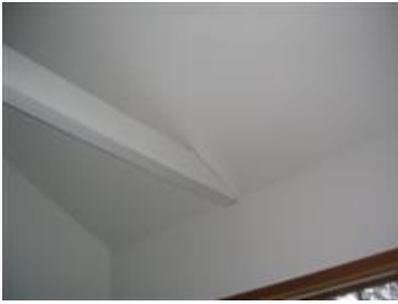
Lateral brace beams in the master bedroom had gaps where they met the ceiling and were allowing some air infiltration. I recommend these areas be better sealed with a flexible caulk to allow for seasonal expansion and contraction of the wood.

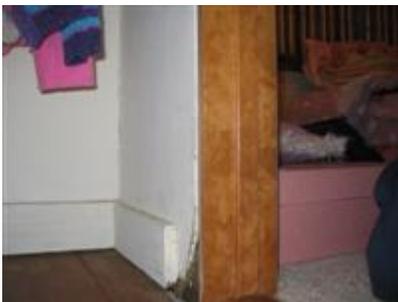
2.2 Picture 1

2.2 Many of the floor/wall junctions in the closets had no trim and leaked air during the blower door testing. (Picture 1) (Picture 2) (Picture 3) I recommend they be caulked/sealed.

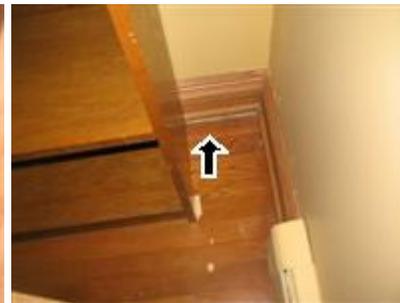
2.2 Picture 4

There was also a gap seen on the right side of the fireplace along the wall at the floor. It should be sealed. (Picture 4)

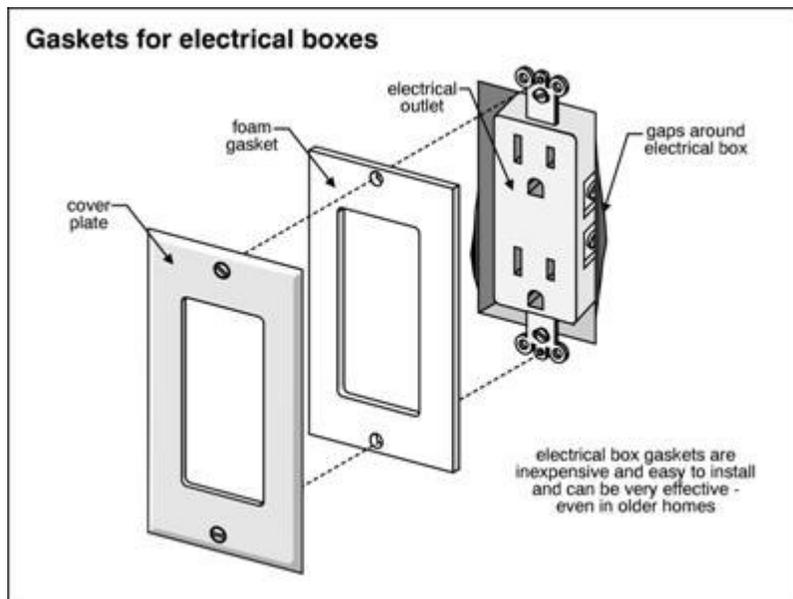
2.3 Picture 1

2.3 Most if not all of the electrical outlets on the exterior walls of the entire home showed significant air leaks when the home was tested. I recommend that each exterior wall outlet and switch have a gasket installed. Child-proof outlet plug-in caps may also help control drafts from unused plugs.

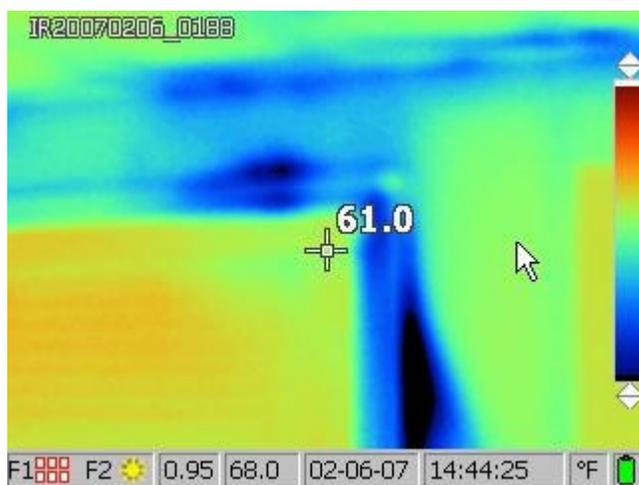
2.4 Picture 1

2.4 Some thermal bridging seen at the top of the green guest bedroom window at the rear wall (Picture 1). There also appeared to be a slight void in the insulation adjacent to the window on the right side. You may wish to inject some expanding foam into this area to compensate.

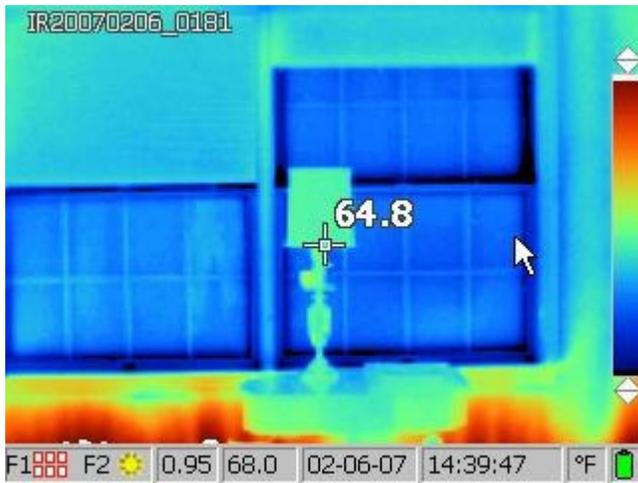
2.4 Picture 2

The bottom of your daughter's playroom/bedroom windows also showed some thermal bridging. (Picture 2) There is little that can be done about this other than to add heavy drapes that might deflect the heat sink effect away from the headboard of the bed in this room.

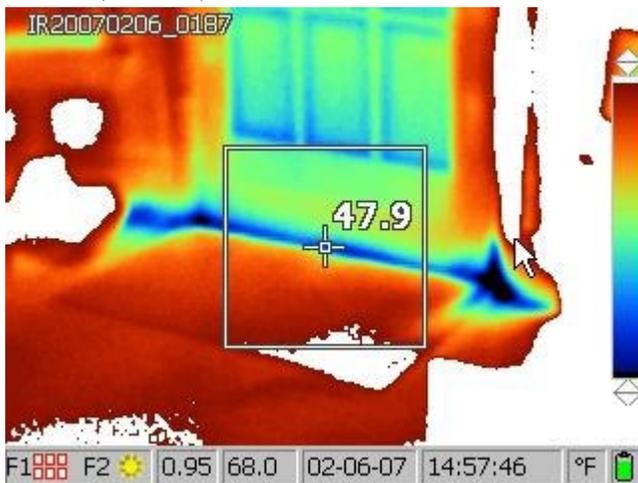
2.5 Picture 1

Doors in the sunroom were also leaking air at their bottoms. (Picture 1) (Picture 2) Replacement or adjustment of the thresholds are recommended. The double doors also leaked where they met in the middle. (Picture 3)

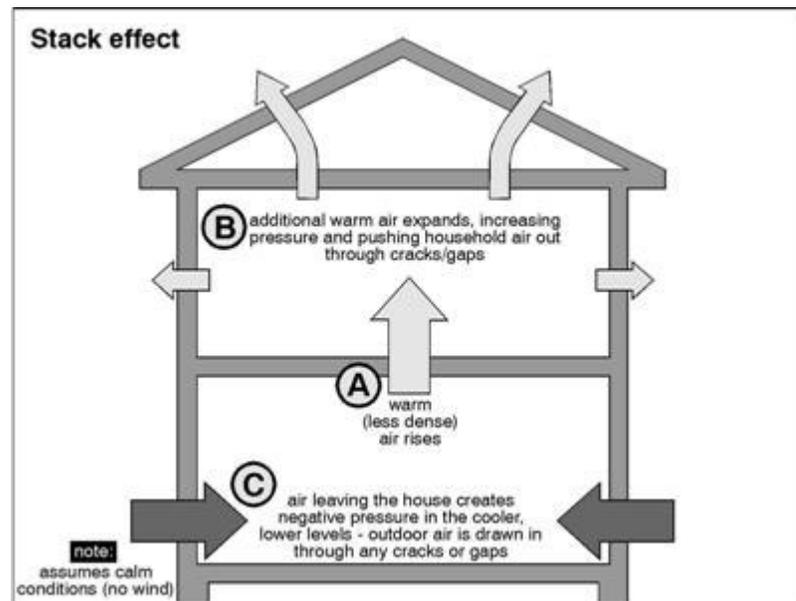
2.5 Picture 4

Stack effect in the home is going to make the air leaks in the sunroom a particularly noticeable and a significant comfort concern. (Picture 4)

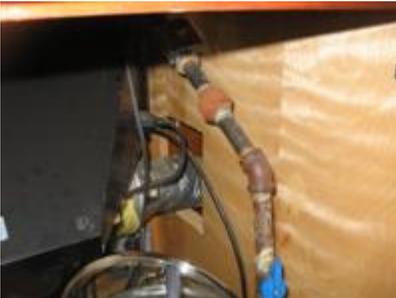
2.6 Picture 1

Vent chase for range vent system was leaking air and could be better sealed. (Picture 1)

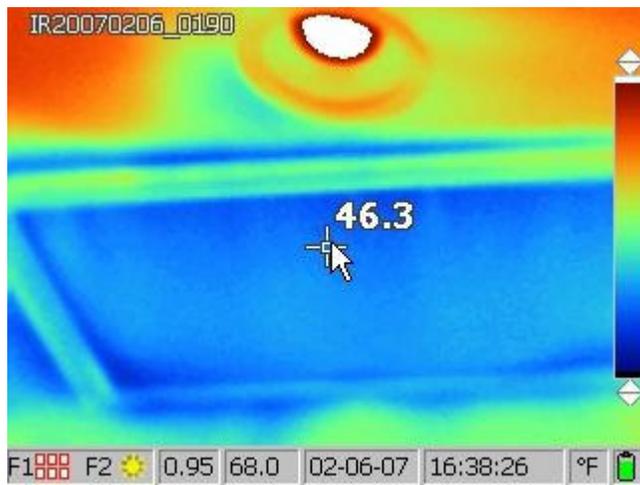
2.7 Picture 1

2.7 Attic scuttle hole leaks air and had no insulation. Recommend properly insulating and sealing it. It was a major source of air leaks during the blower door test. (Picture 1)

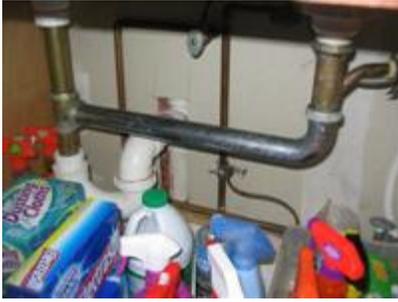
2.8 Picture 1

2.8 Wall penetrations for the waste pipe lines under the kitchen and bathroom sinks were a source of air leakage. (Picture 1) (Picture 2) I recommend they be sealed with expanding foam.

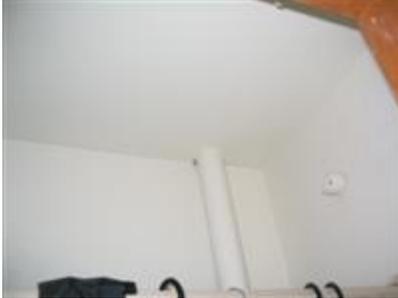
2.8 Picture 3

A pipe passing through one closet could be better sealed through its penetration points.

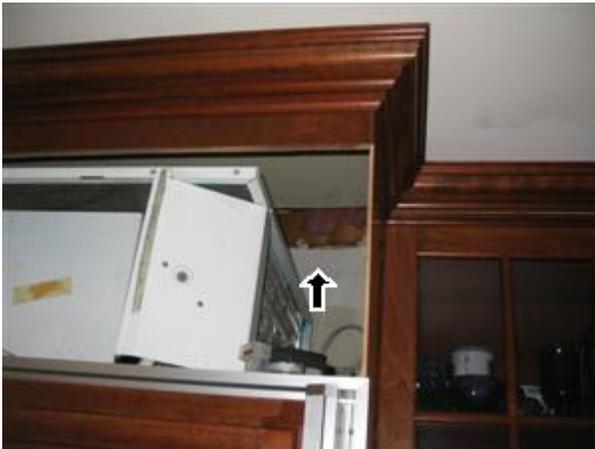
2.9 Picture 1

2.9 The ceiling behind the refrigerator inset area was open and a major source of air infiltration during the blower door test. I recommend the ceiling area be properly covered over.

The largest air loss areas were in the ceiling behind the refrigerator and in the master bedroom at the knee-wall storage doors. While I recommend that you heed all recommendations set forth in this report, if you were to perform no other remediation activities besides sealing these aforementioned areas you would cut the majority of your infiltration losses.

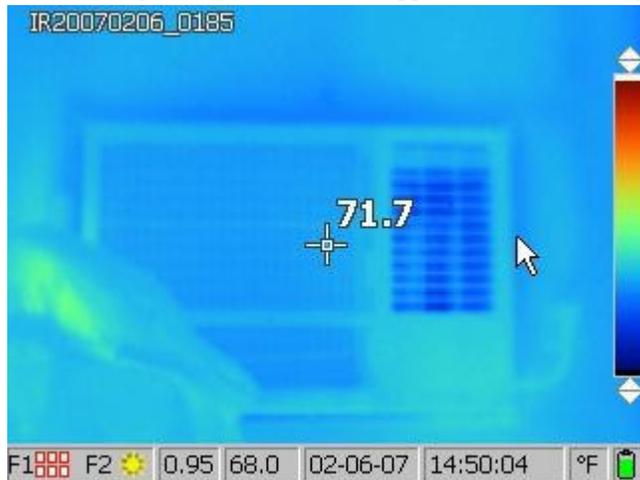
4.1 Picture 1

4.1 The through-wall air conditioner appeared to be relatively well sealed. (Picture 1)

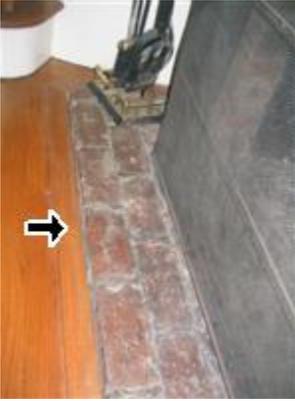
4.3 Picture 1

There was an air gap noted where the hearth stones met the flooring. You may wish to better seal this gap.

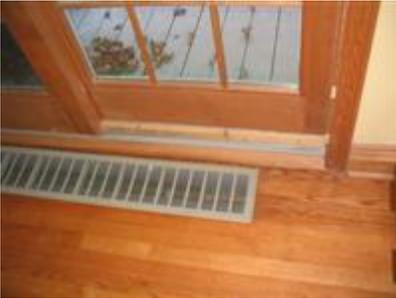
4.5 Picture 1

4.5 Duct by front sliding door leaked some air. You may wish to better seal or gasket this register.
