## Residential Realty Inspection Report

Property Address:  
5 Brentwood Dr.  
Sample City, NY 12345

<b>Date:</b> 12/1/2006	<b>Time:</b> 11:30 AM	<b>Report ID:</b> Res Sample 1
<b>Property:</b> 5 Brentwood Dr. Sample City, NY 12345	<b>Customer:</b> Michael Smith Laura Smith	<b>Real Estate Professional:</b> Mike Bell Mike Bell Realty

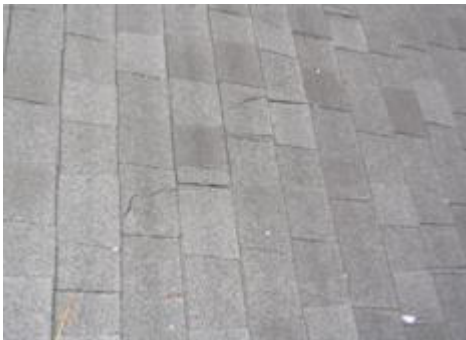
1.0 Picture 1

1.0 Roof appears to be generally in sound condition but there were a few hairline cracks in some shingles. Monitor and tar/patch as needed.

Roof has algae and moss growing on it. (Picture 1) This is indicative of a roofing which stays moist for extended periods after rain (usually due to heavy tree cover in areas and/or roof on north side). While algae is typically only a cosmetic concern, moss has a root system which tends to deteriorate shingles over time. I recommend that the area be cleaned of this debris. Some people report success in treating the condition with 'B-Bright' or 'Oxyclean' solutions (or equivalent).

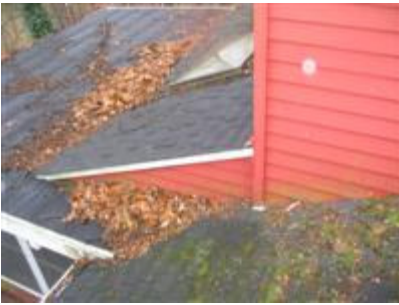
1.0 Picture 3

Complex roofs are sometimes prone to developing leaks over time. Monitor where roof planes meet and tar/patch as needed if leaks develop.

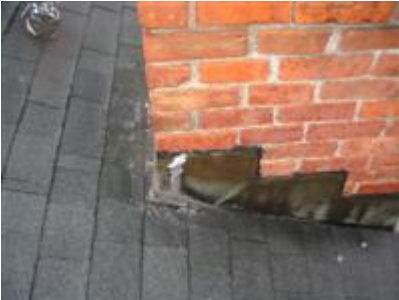
1.1 Picture 1

1.1 Flashing around the chimney has lifted slightly at the top and side. This area may need to be monitored periodically and tarred/patched as needed. There were no signs of any current leaks.

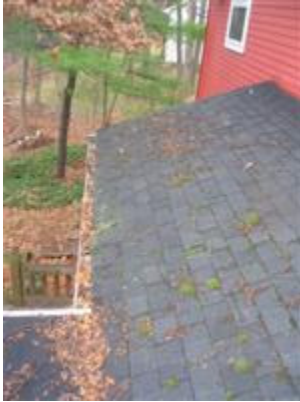
1.3 Picture 1

1.3 Gutters are full of debris in areas and need to be cleaned. (Picture 1) The debris in gutters can also conceal deterioration or leaks that are not visible until cleaned. Gutters on a home which has close tree cover may need frequent cleaning to keep them clear and operating properly. (Picture 2)

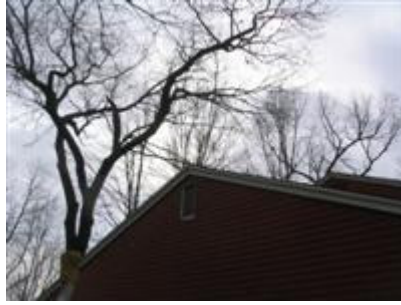
1.3 Picture 2

Some vegetation was growing in the gutters.

The gutters have gutter-guard screening. Some of the screens have fallen into the gutters. When in disrepair or when improperly installed, they tend to catch more debris and clog than a gutter without them. I recommend that they either be repaired/installed properly or removed entirely.

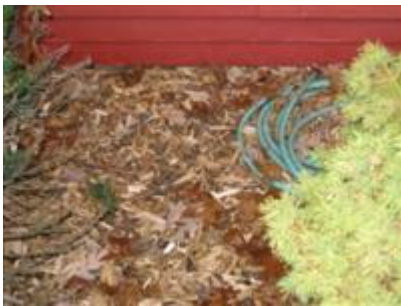
2.0 Picture 1

2.0 Siding-to-soil contact found. (Picture 1) (Picture 2) This wicks moisture into the wood and attracts wood destroying insects. Recommend correcting condition to provide ground clearance of six to eight inches where possible and repairing/replacing wood that shows decay.

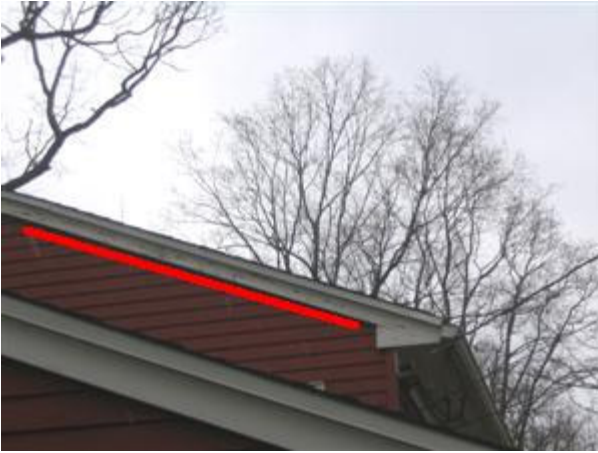
2.1 Picture 1

2.1 Fascias had several areas with carpenter bee damage evident. (Picture 1) Carpenter bees rarely cause structural damage, however, they are a nuisance, and in significant numbers, or from re-infestation, can cause a great deal of cosmetic damage.

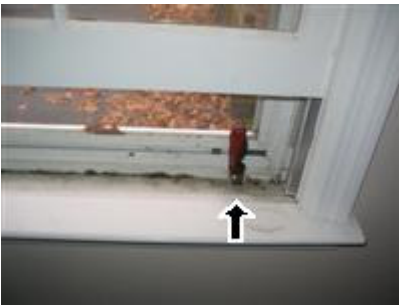
2.3 Picture 1

2.3 Weep holes at storm windows are sealed at many windows. There should be open weep holes at the bottom of storm window frames so that condensation does not pool on the wooden window sills and deteriorate them.

At least two sills showed wood rot from water. (Picture 1) (Picture 2)

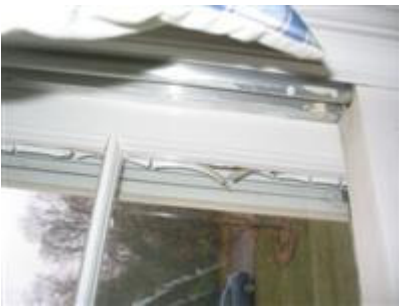
2.3 Picture 3

Glazing between glass panes are failing at some windows. (Picture 3) Recommend re-glazing with DAP '33' or similar product.

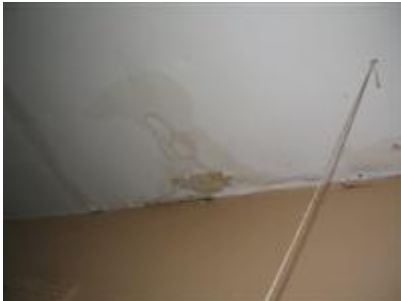
4.0 Picture 1

4.0 Signs of prior water staining seen at ceiling from prior leak. The leak appears inactive/cured.

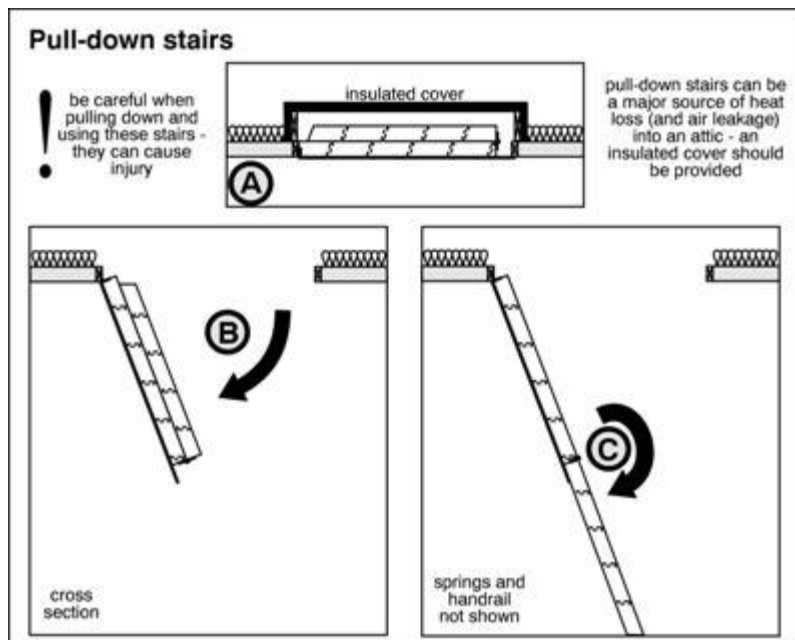
4.6 Picture 1

4.6 Attic pull-down stairs are uninsulated and poorly sealed. They can be a significant source of cold air infiltration and heat loss. I recommend that you install an insulated attic access cover.

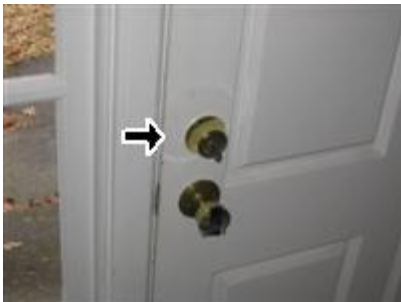
4.8 Picture 1

4.8 Interior doors opening to the exterior should not have dead-bolt locks keyed on both sides. The locks can trap someone in a fire. The lock should be replaced with one which can be operated from the inside without a key.

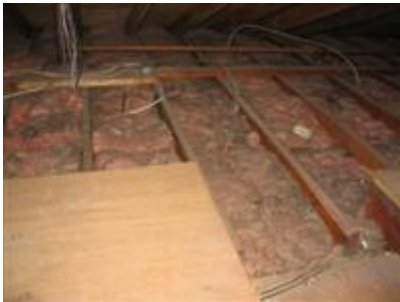
5.0 Picture 1

5.0 Insulation in the main attic area was settled and below levels used in modern construction.(Picture 1) Heat loss into the attic area during winter months can cause high heating costs as well as be a contributing factor in the formation of ice dams. Recommend increasing the level of insulation.

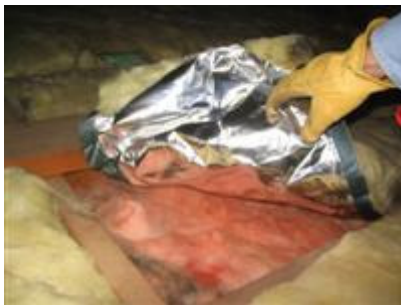
5.0 Picture 4

There were two layers of insulation in some places in the attic. Some of the second layer of insulation was installed with a vapor barrier. Two separate vapor barriers can cause condensation problems unless the second barrier is in the first 1/3 of the layer. I recommend additional unfaced insulation be installed to increase the overall thickness or the second vapor barrier should be removed or slashed so that it does not trap moisture.

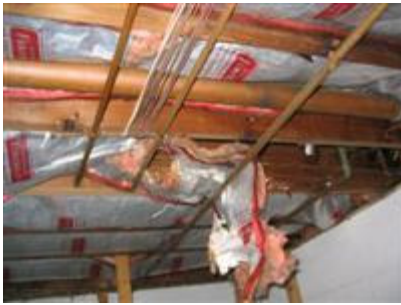
5.0 Picture 6

Insulation in basement is installed with "Paper or Kraft" facing away from heated area of home. Paper/Foil side should always face the "Heated Space" or condensation could occur within its layers. When the vapor barrier has been installed upside down it will trap moisture and promote decay on the wood it is in contact with. Recommend repair or replace as needed using a qualified person. Insulation is failing in some areas of the unfinished basement. Recommend repairing it as needed.

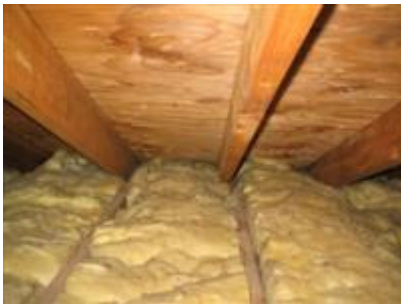
5.1 Picture 1

Insulation is covering soffit area in the attic and reducing effective ventilation.(Picture 1) Recommend inserting baffle in each rafter bay to promote better soffit air flow.

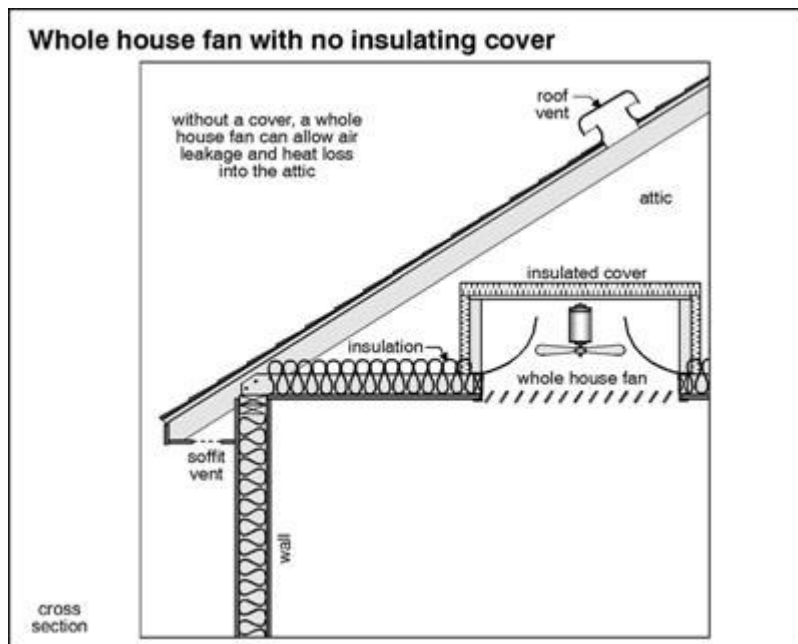
5.3 Picture 1

5.3 Whole house fan in attic did not appear to have an insulated cover available for winter. This can result in a great deal of heat loss during the winter. You should consider having the fan covered during the heating season and be sure to remove the cover before putting it back into service during warm weather.

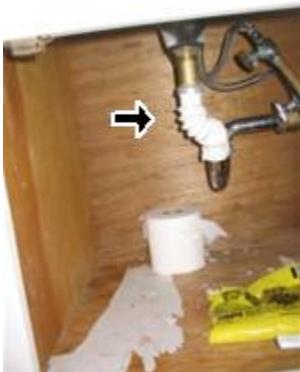
6.2 Picture 1

6.2 Universal soft-sleeve waste connection seen at Private Bath sink. While there was no sign of leakage from it during the inspection, they tend to wear out over time. I recommend that more permanent connection be made when it comes time to replace it..

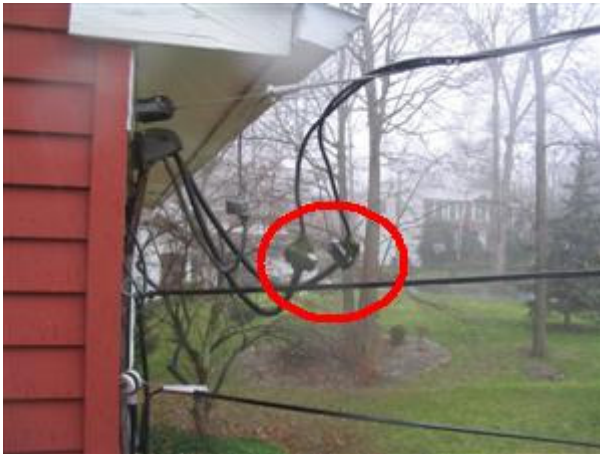
7.0 Picture 1

7.0 Insulation for electrical service conductors connectors ("bugs") is worn/missing and the connectors are exposed. (Picture 1) Under the right conditions, the connections may arc and become a electrical fire hazard. They need to be re-insulated.

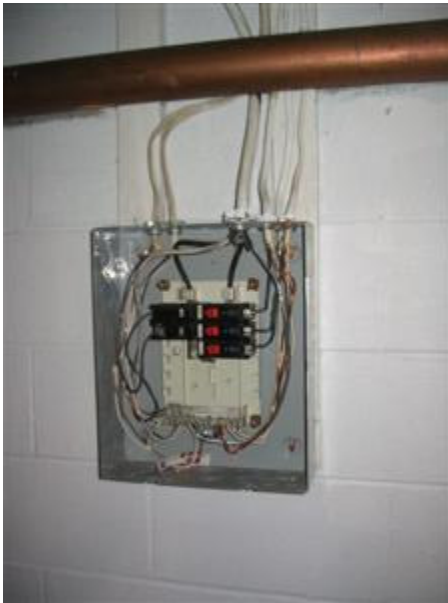
7.2 Picture 2

View of interior of electrical sub-panel. (Picture 2) The sub-panel has the ground and neutral bonded together. This is a prohibited practice because it allows normal electrical flow back to the main panel along the ground path. This can allow shock or electrocution of anyone working on sub-panel circuits. I recommend that the wiring be repaired or replaced by an electrician so that the neutral wire (normal electrical return path) is properly isolated from the ground wire (emergency return path) at the sub-panel.

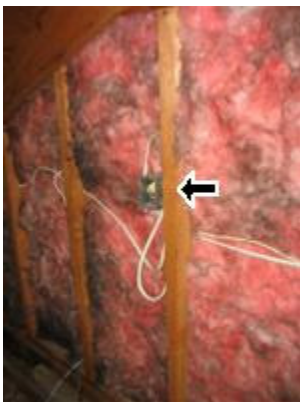
7.4 Picture 1

7.4 Exposed wiring seen in some areas. Splices and wire nuts should be properly enclosed in electrical utility boxes.

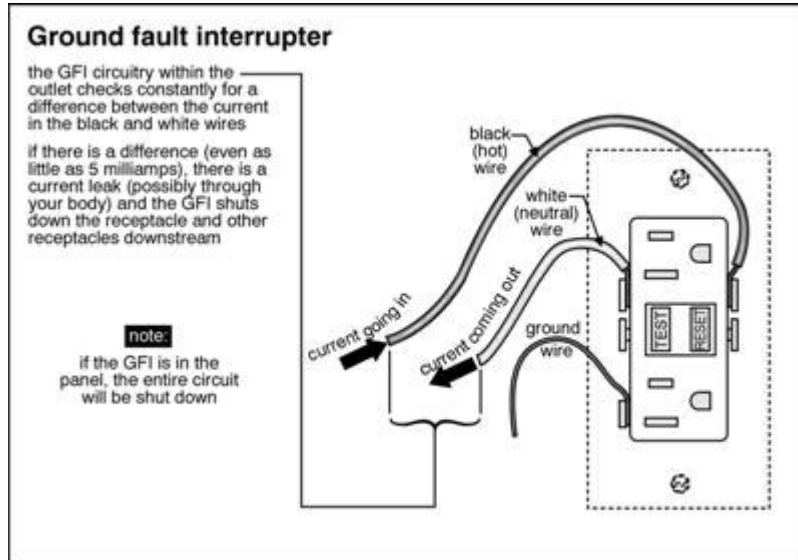
7.6 Picture 1

7.6 While GFCI protection was not required in all applicable areas when the home was built, it would be a good idea to add the protection now by installing either GFCI outlets or GFCI circuit breakers at exterior outlets, and interior outlets within 5 feet of water supplies in bathrooms and kitchen as needed.

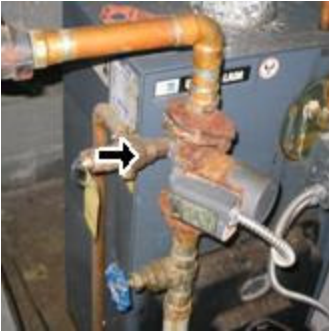
8.4 Picture 1

8.4 Considerable rust seen at distribution pump. (Picture 1) You may wish to have an HVAC company review and perform any needed maintenance.
