## Residential Realty Inspection Report

Property Address:  
5 Brentwood Dr.  
Sample City, NY 12345

<b>Date:</b> 12/1/2006	<b>Time:</b> 11:30 AM	<b>Report ID:</b> Res Sample 1
<b>Property:</b> 5 Brentwood Dr. Sample City, NY 12345	<b>Customer:</b> Michael Smith Laura Smith	<b>Real Estate Professional:</b> Mike Bell Mike Bell Realty

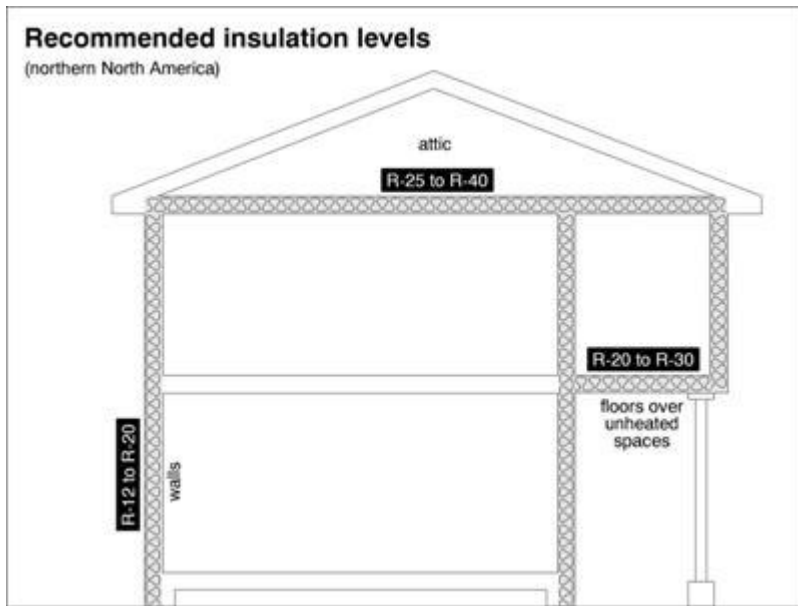
5.0 Picture 3

There were two layers of insulation in some places in the attic. Some of the second layer of insulation was installed with a vapor barrier. Two separate vapor barriers can cause condensation problems unless the second barrier is in the first 1/3 of the layer. I recommend additional unfaced insulation be installed to increase the overall thickness or the second vapor barrier should be removed or slashed so that it does not trap moisture.

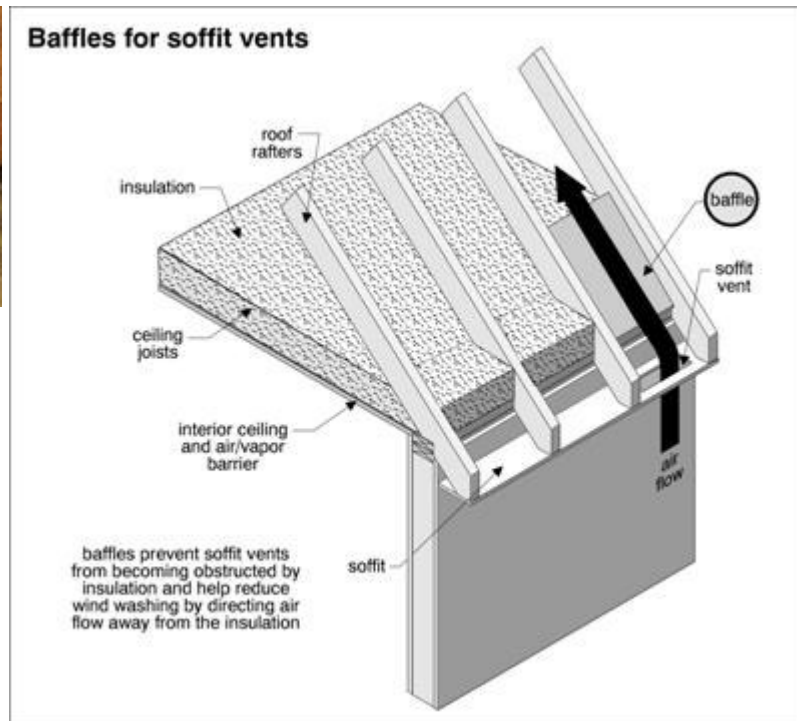
5.1 Picture 2

Ventilation was not added, when most recent roof covering was installed. Recommend increasing the ventilation to promote life expectancy of covering.

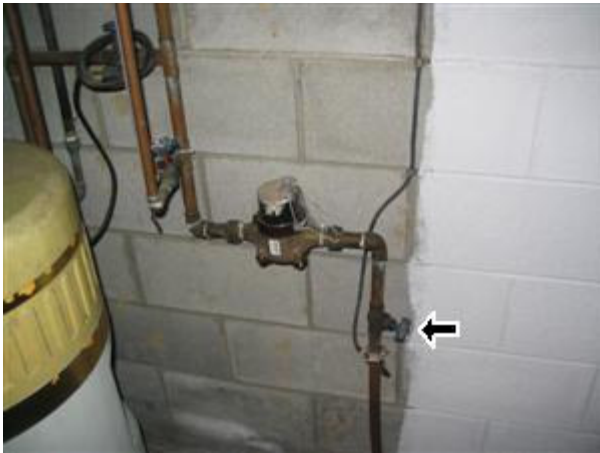
6.5 Picture 1

6.5 The main shut off is the blue knob located in basement at water meter. (Picture 1) This is for your information.

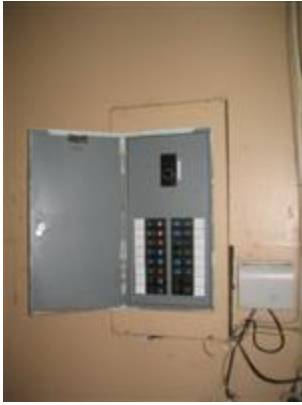
7.1 Picture 1

7.1 Main panel box is located at garage. (Picture 1) Sub panel box is located at basement. (Picture 2) This is for your information.

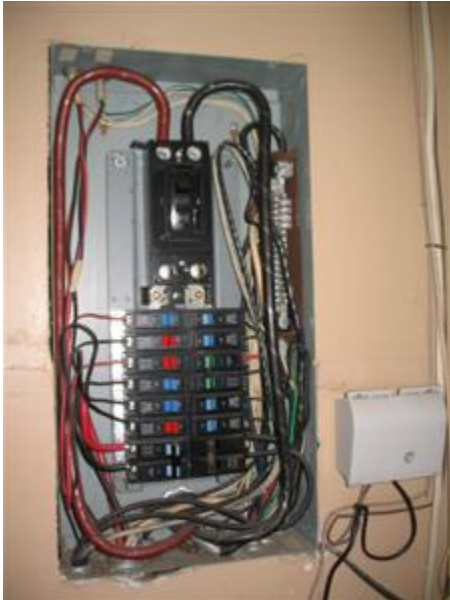
7.2 Picture 1

7.2 View of interior of main electrical panel. (Picture 1)

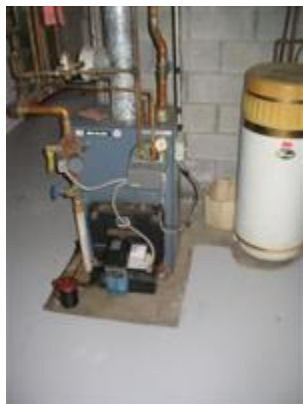
8.0 Picture 1

8.0 View of heat system.(Picture 1)

Heating capacity of system (from furnace/boiler data plate) is 151,000 BTU/Hr (For your information). A general rule of thumb is that most homes need between 30 to 60 BTU per hour per square foot of heated space. Older homes typically need more, newer homes typically need less.

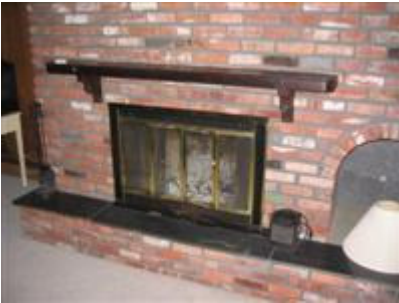
8.6 Picture 1

**8.6** View of fireplace. (Picture 1) Be careful when selecting fuel for your fireplace. Softwoods like firs, cedars and pines can give off creosote which will coat the inside of the chimney and can eventually lead to a chimney fire. Exceptionally hard woods like locust or ash can burn too hot, resulting in warped or damaged flue, chimney and firebox components. You are usually best off using common hardwoods like oak, maple, and fruitwood.

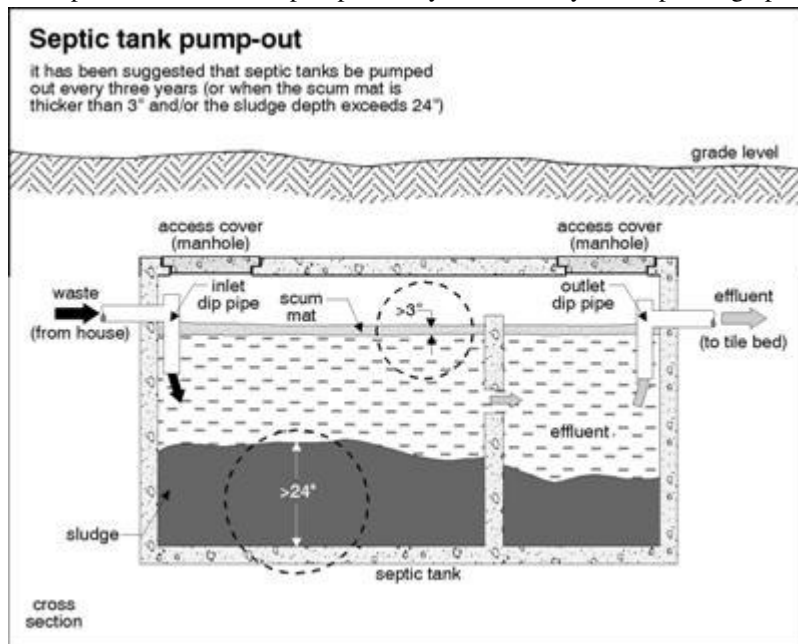
10.2 Picture 1

10.2 Septic tanks should be pumped every two to five years depending upon use.
